**Faculty of Engineering**

Department of Textile Engineering

**Study on Different Types of Sewing Fault & it's Remedies.**

**Course Title:** project (Thesis)

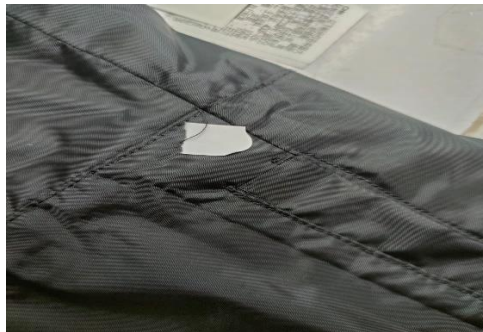
**Figure: 2.4.1 Uncut Thread.**

Excess thread is hanging on garments after manufacturing, which is happened for unskilled workers. Workers training is required to avoid this problem.

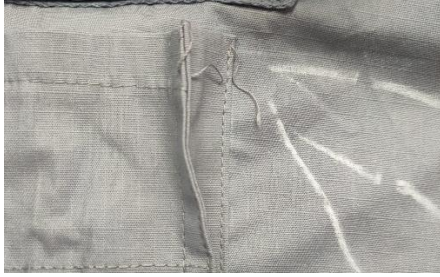
Figure: 2.4.2 Open Stitch

when a thread edge comes out after sewing is called open stitch.

- Back stitch missing in sewing end edge.

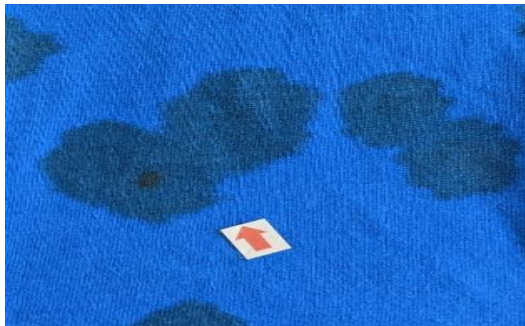
Figure:2.4.3 Oil Spot.

A spot is found in the garments surface which do not have any deep color is called oil spot. This decrease the quality of garments

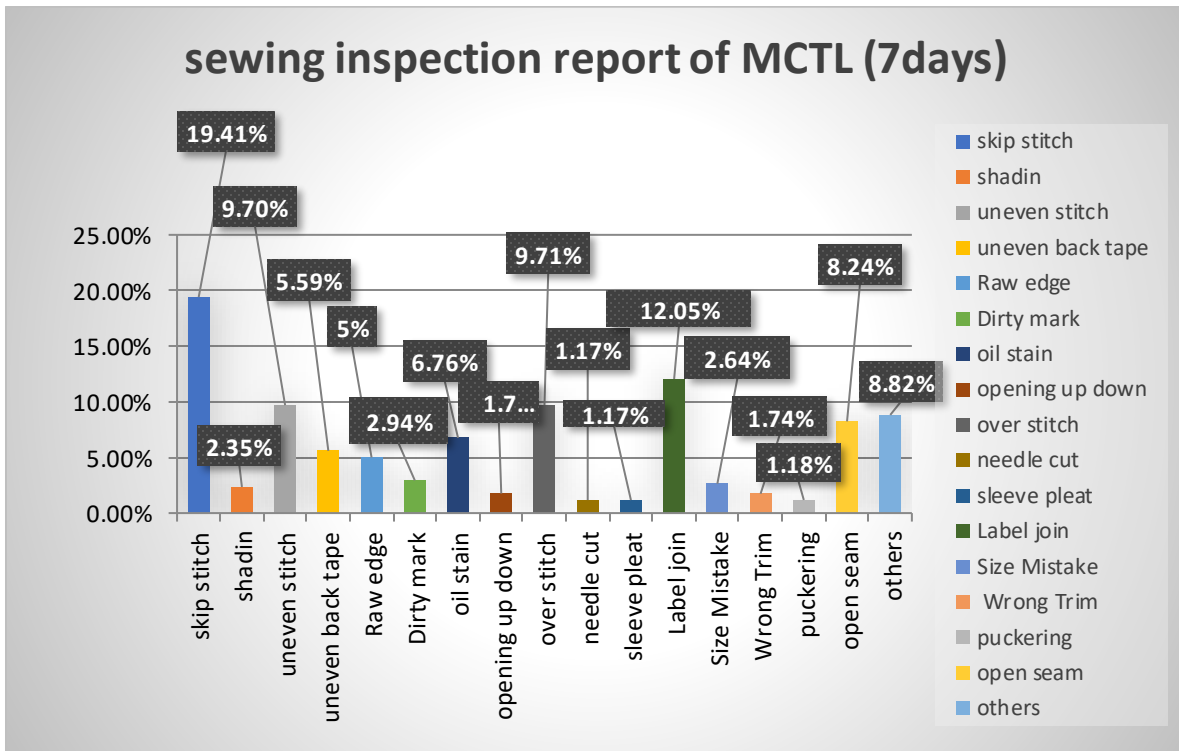
**Figure:4.1** sewing inspection report of MCTL (7days)

This is the summary of End Line Inspection Report which we have collected from Magpie Composite Textile Limited. We have collected 7 days reports from different Line and Different Buyers Products. And the Result is visible in the pie chart, which are 21% skip stitch, 11% Uneven Stitch, 11% puckering, 9% open seam, Label Join 13%, 2% shading, 2% Needle cut, 2% wrong trim, 7% sleeve Pleat, 3% Raw edge, 2% Uneven Back Tape, 7% sleeve Pleat, 3% Dirty Mark and 5% others.

So, most occurring Fault in Magpie composite Textile ltd is skip stitch uneven stitch and Label Join.

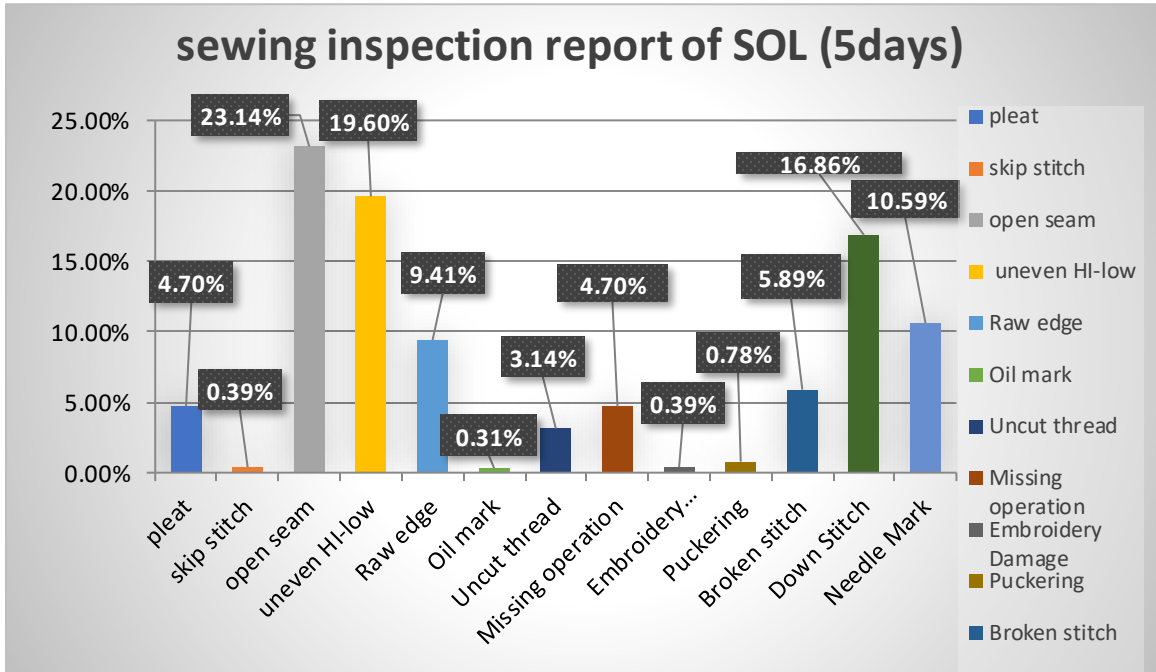
Figure: 4.2 sewing inspection report of SOL (5days)

This the Summary of End Line Inspection report which is collected by us from SNOWTEX outwear ltd. We have collected 5 days report from different production line. And the result is visible in the pie chart. Where 23% Open Seam, 16.86% Down Stitch, 20% uneven HI Low, 10.59% Needle Mark, 5.89% broken Stitch, 4.70% Missing Operation, 0.39% Skip Stitch, 4.70% pleat. From the report we can see that the highest amount of fault is Open Seam which is 23.14% and the Lowest occurring fault is skip stitch in SNOWTEX outwear ltd.

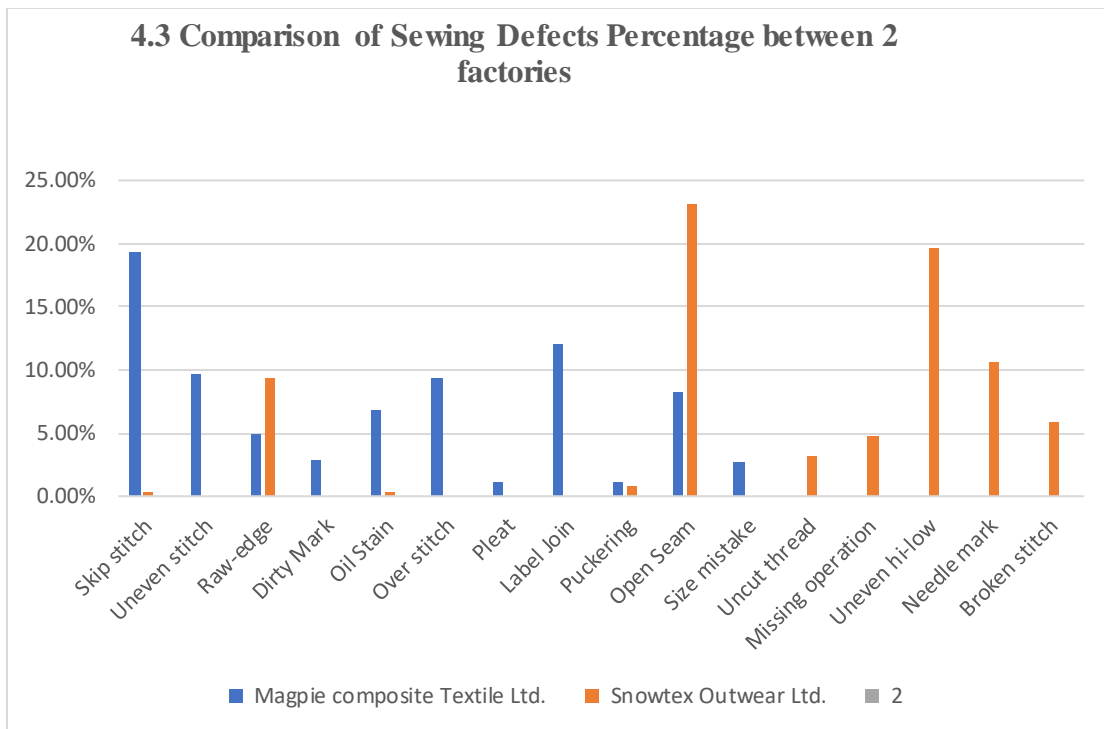
Figure: 4.3 Comparison of Sewing Defects Percentage between 2 factories

This is the comparison Table of sewing Defects in percentage between 2 factories those factories are Magpie composite textile Ltd (MCTL) and Snowtex Outwear Ltd (SOL). From the table we can see that defects are varied for different factories. Skip stitch is 19.41% in MCTL but 0.39% in SOL, uneven stitch is 9.70% in MCTL & 0% in SOL, Raw-edge is 5% in MCTL and 9.41% in SOL, Dirty Mark is 2.94 in MCTL & 0% in SOL, oil stain is 6.76% in MCTL & 0.39% in SOL, over stitch is 9.41% in MCTL & 0% in SOL, pleat is 1.17% in MCTL & 4.70% in SOL , Label join is 12.05% in MCTL & 0% in SOL, puckering is 1.18% in MCTL & 0.78% in

SOL, Down Stitch is 16.86% in SOL but 0% in MCTL, size mistake is 2.64% in MCTL and 0% in SOL, uncut thread is 0% in MCTL & 3.14% in SOL missing operation is 5 in MCTL and 4.70% in SOL, uneven hi- Low is 0% in MCTL but 19.6% in SOL, Needle Mark is 0% in MCTL but 10.59% in SOL . here defect percentage are different for different factories. From upper information found some defects which are common in both Factories those are Skip stitch, Open seam, Uneven stitch, Raw edge, Down stitch.

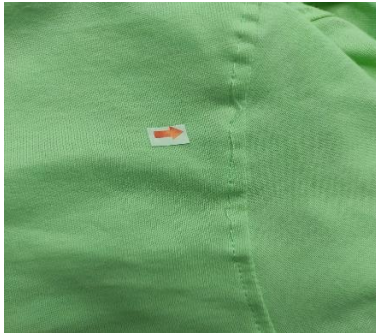
**Figure: 4.4.1 SkipStitch.**

This is a sewing fault Occurred for machine defect.

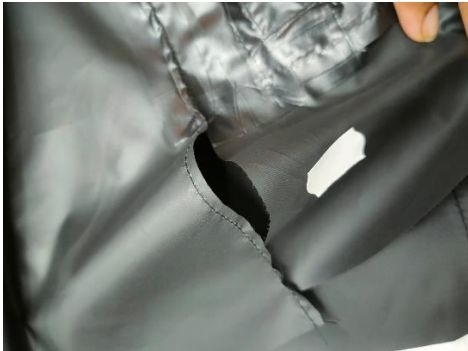
Figure: 4.4.2 Open Seam

This is the sewing problem where two edge of fabric not attached completely after sewing.

- Needle and looper timing mismatch.
- Improper parts handling of garments.

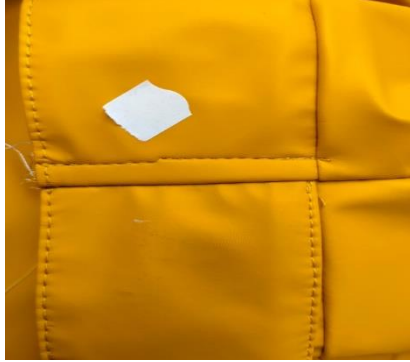
Figure: 4.4.3 Uneven Stitch

The stitch line is not even or not straight is called uneven stitch.

- By Avoiding excess pulling garments during sewing.
- By using good quality thread.
- By operators training.
- By using right Needles according to fabric types.

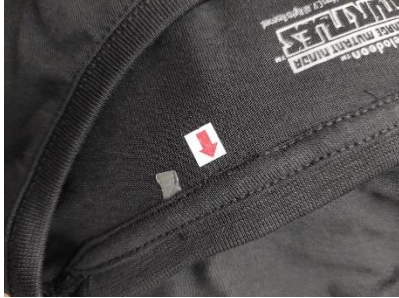
Figure: 4.4.4 Down stitch

**4.4.4 Downstitch:** Down stitch can be defined as a fault where stitch line did not place in the right path.

- For unskilled operator.
- Carelessness in work.
- Improper machine speed.

- By setting proper guide.
- By using skilled operators.
- By maintain machine speed.

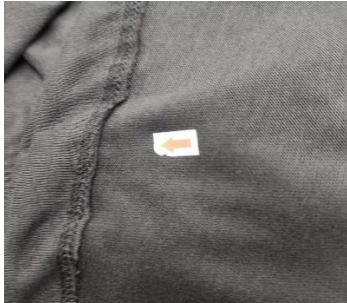
Figure: 4.4.5 Raw- edge.

**4.4.5 Row-edge:** Excess fabric is shown in sewing line after sewing is raw-edge.

- For unskilled operator.
- Improper panels cutting.
