**Assessment of river channel shifting and socio-economic impacts on
local settlements of the Jamuna River, Pabna, Bangladesh.**

This Thesis Report Presented in Partial Fulfilment of the Requirements
for the Degree of Bachelor of Science (B. Sc) in Environmental Science
and Disaster Management (ESDM)

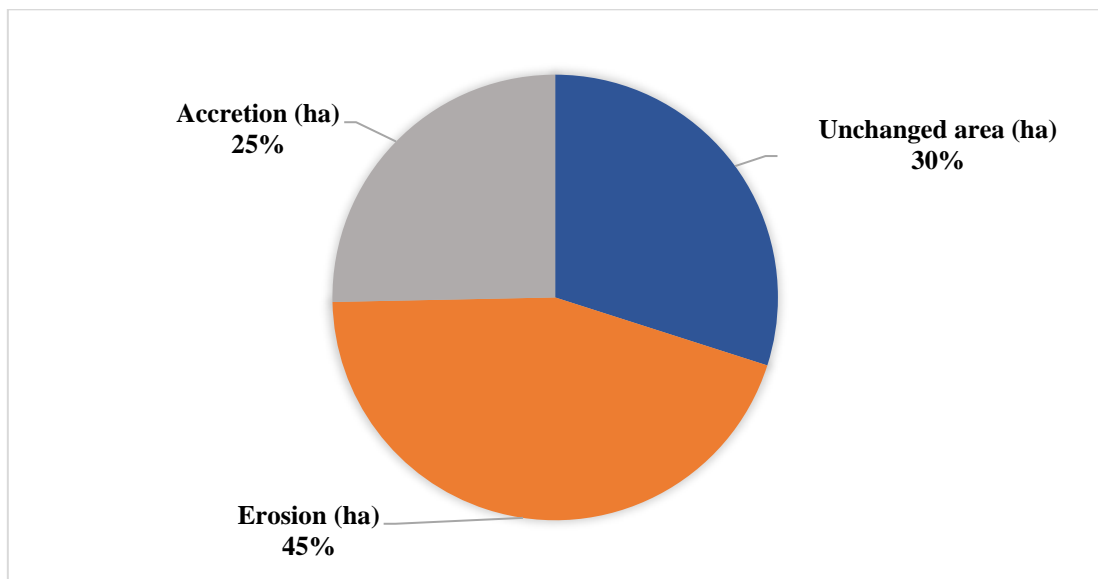
Figure 10: Erosion-accretion result, Jamuna river study area 2002-2012
(own illustration)

In figure 10, the erosion-accretion result of the Jamuna river study area has been shown from 2002 to 2012. However, the blue colored area indicates about the river unchanged area, orange color indicates about the eroded area and finally the green color indicates about the accreted area. Here all the measurements of the area have been calculated in

hectare (ha) unit. If the figure 10 is considered as 10 years' time period, it can be said that, 30% of the total area has remained unchanged during the decade, 45% area has been eroded and 25% area has been accreted in that ten years.

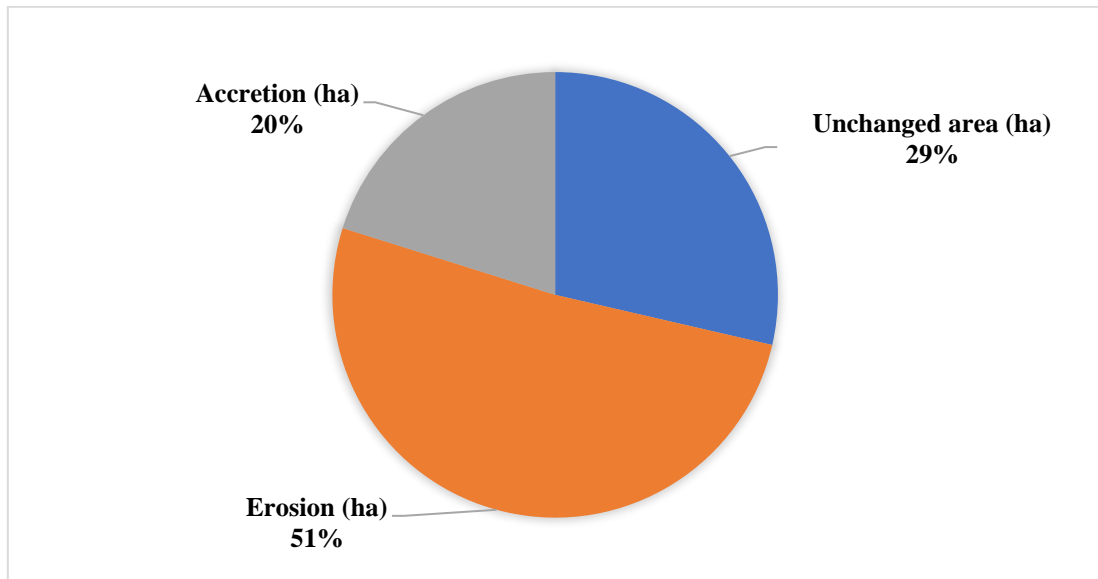
Figure 11: Erosion-accretion result, Jamuna river study area 2012-2022
(own illustration)

In figure 11, the erosion-accretion result of the Jamuna river study area has been shown from 2012 to 2022. However, the blue colored area indicates about the river unchanged area, orange color indicates about the eroded area and finally the grey color indicates about the accreted area. Here all the measurements of the area have been calculated in hectare (ha) unit. If the figure 11 is considered as 10 years' time period, it can be said that, 29% of the total area remained unchanged during the decade, 51% area has been eroded and 20% area has been accreted in these ten years.

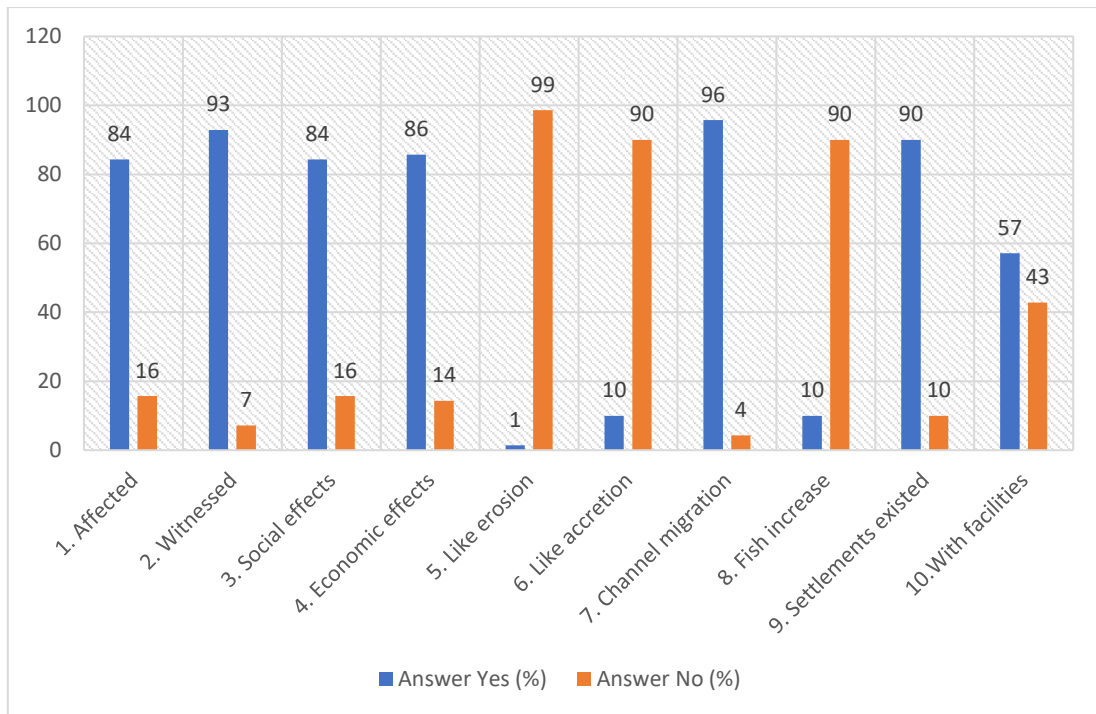
Figure 12: Questionnaire survey result analysis of Jamuna river study area (own illustration). **Source:** Field survey, Nishad, 2022.

Raw data that have been found from the questionnaire survey according to the figure 12, 84% of the total population have directly experienced damage/loss of households, cultivation lands, crops, domestic animals, etc. due to river erosion while rest of the 16% have not experienced that. 93% people have seen others in their neighborhood who have faced the same problem where 7% people have not seen anyone like this or even did not have experience in real life. 84% people have been affected by various social effects which include: lack of food, education, transportation, living problem, etc. while the other 16% have not. 86% people have been affected by various economic factors including: loss of capital, loss of property, loss of commercial product, unemployment, etc. while the other 14% have not experienced it. Almost everyone supported that river erosion is bad for them. Similarly, 10% agreed that river accretion is good for them and rest of the 90% denied. 96% people said that the river channel has been shifted and other 4% did not notice at all. 90% people said that fish population has been reduced comparing to previous twenty years while the other 10% said no. 90% of the interviewees said there were trees, households, and agricultural lands near the river bank area in previous decades while the other 10% did not notice that. 57% people have the emergency facilities including concrete road, medical center, transport system, multipurpose disaster shelter, pure drinking water, sanitation etc. while rest of the 43% people do not have these facilities and most of them are from Char Kallyanpur.

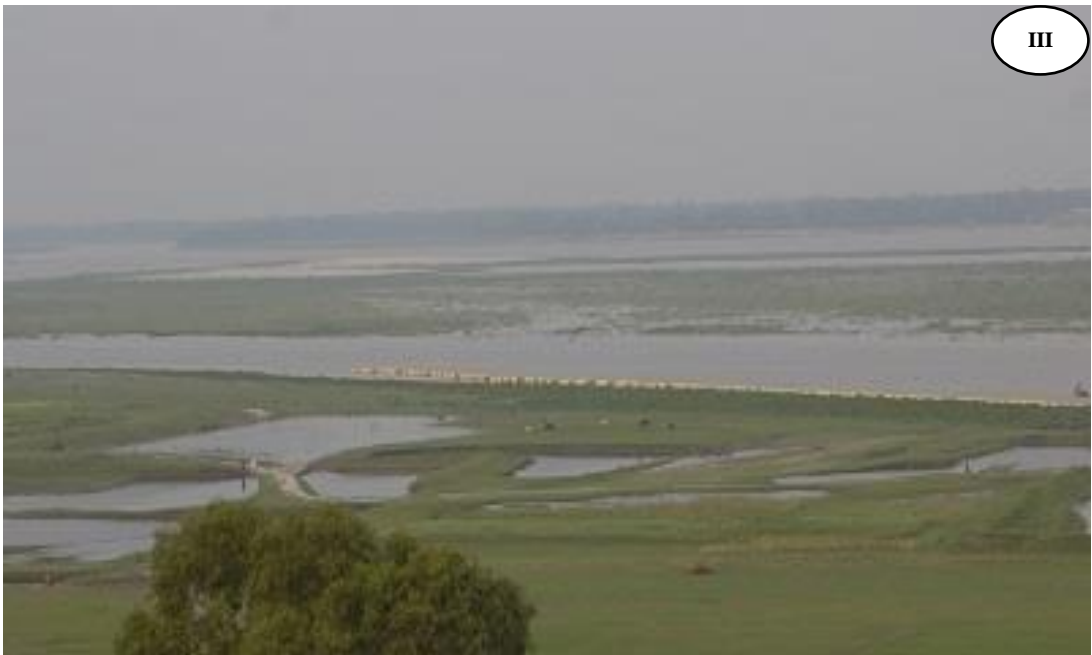
III: River Jamuna Braiding Process. Location: Char Buramara, Bera, Pabna.

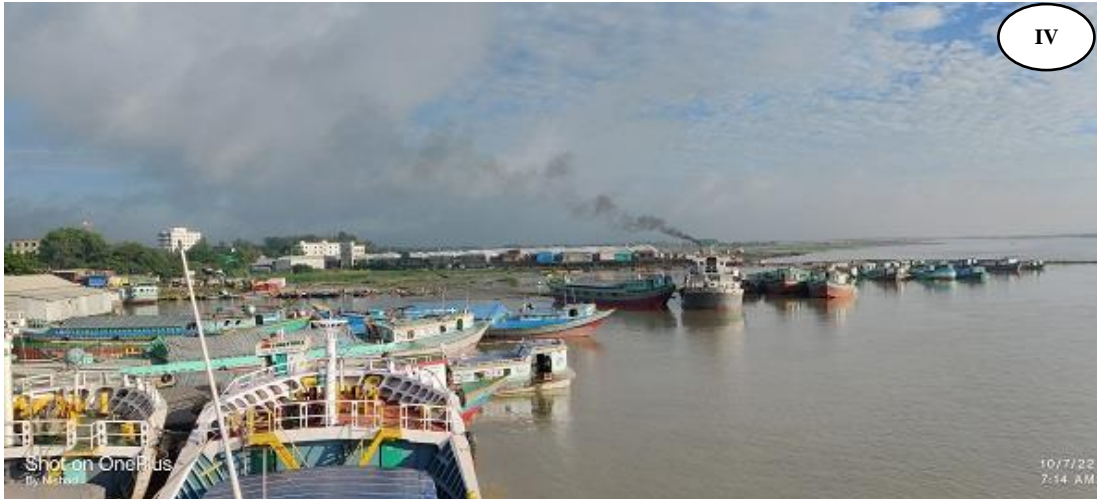
IV: Bankline shifting due to less water level. Location: Nagarbari business area, Bera, Pabna.

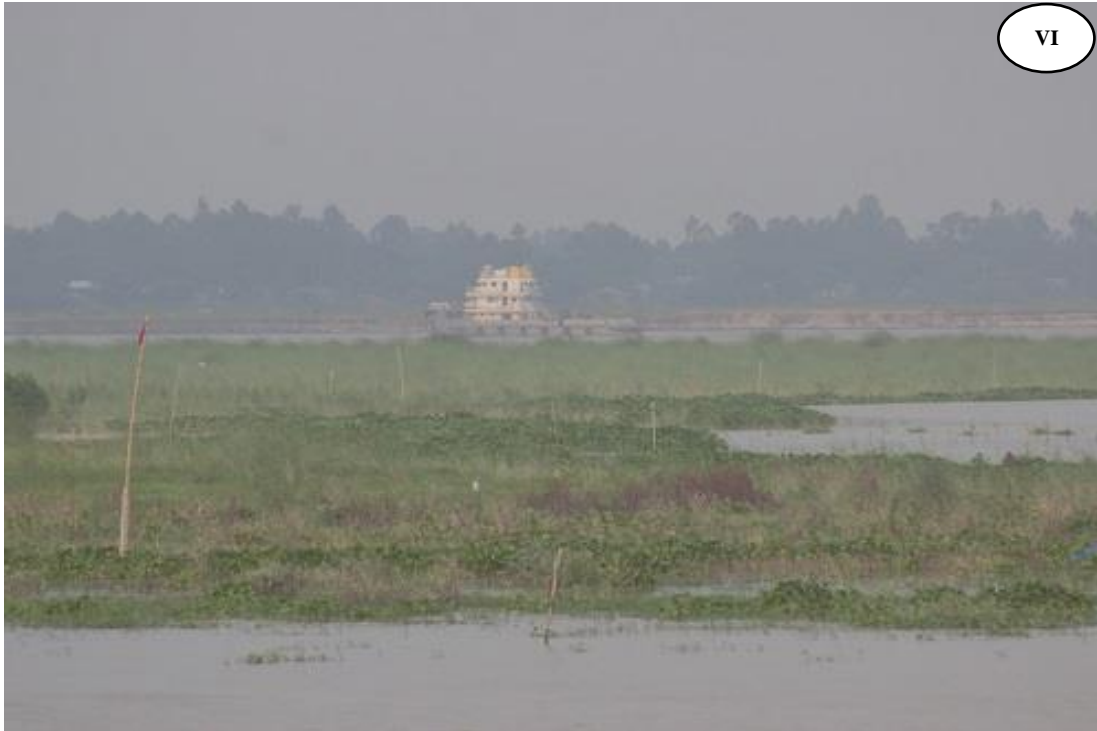
VI: New char area increasing due to accretion between Kallyanpur and Nagarbari.

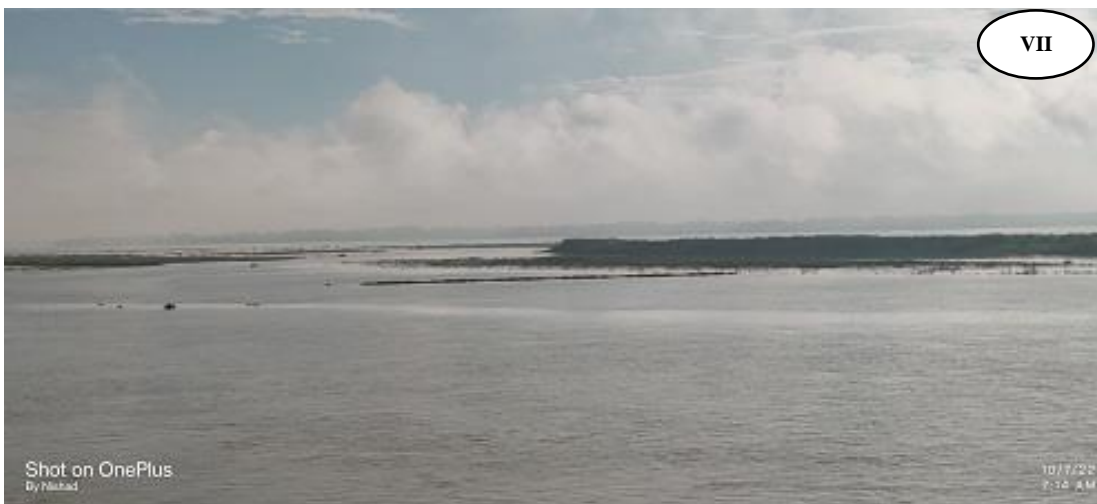
VII: Accreted land area turning into vegetation cover, Nagarbari, Bera, Pabna.
